TE KĀHUI WHAKAMANA
RUA TEKAU MĀ IWA
PIKE RIVER
RECOVERY AGENCY

It's been a while since you've heard from us

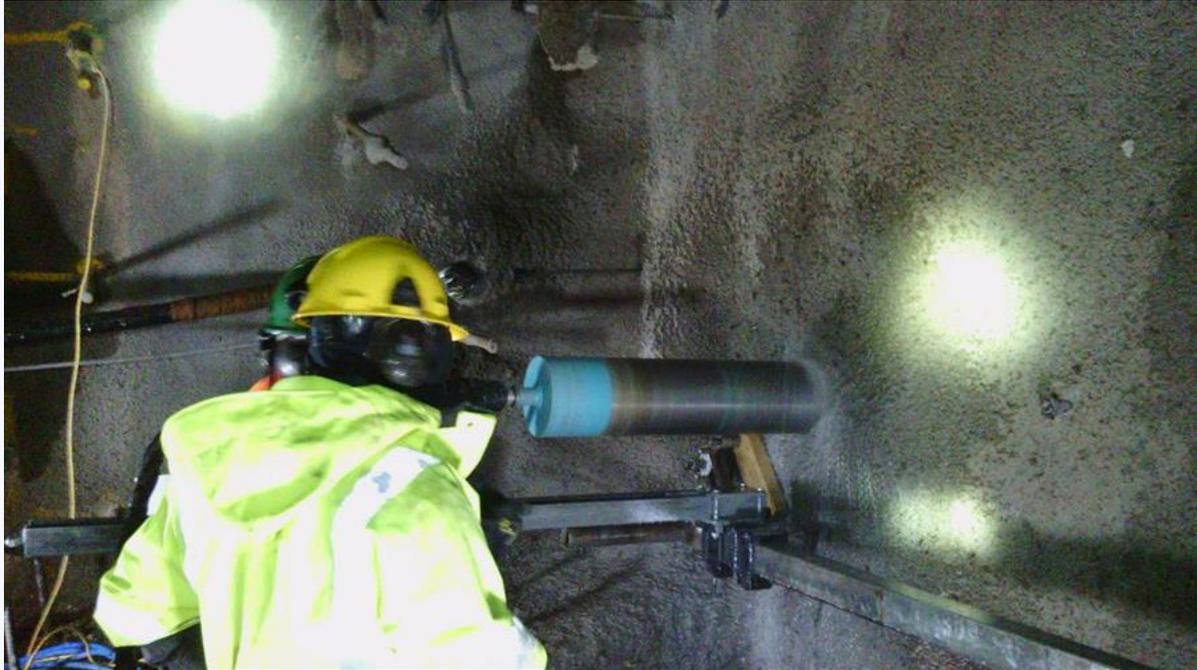
One of the concrete cutting contractors drilling into the 800mm seal 30m into the Pike River Mine drift.

To allow drilling to commence so we could remove the concrete covering the doors 30 metres into the mine drift (access tunnel), we had to lower the pressure as you can't drill into a pressurised area - to do this we had to stop pumping nitrogen. The other thing we had to do was bring fresh air into the drift up to 180m as we can't drill into a nitrogen environment as well. After two and a half hours of drilling we encountered the unexplained oxygen reading at borehole 51.

Since then, we have confirmed it was a faulty tube and replaced this, tested all the other gas monitoring lines that run up over the hill and in through the portal, we have resumed concrete cutting and started removing parts of the seal, and we have been sorting out some other jobs that need to happen before we re-enter.
